FHWA/IN/JTRP-2009/34

Final Report

**INNOVATIVE BRIDGE CONSTRUCTION
PROGRAM: IMPLEMENTATION OF FULL-DEPTH
BRIDGE DECK PANELS IN INDIANA**

March 2010

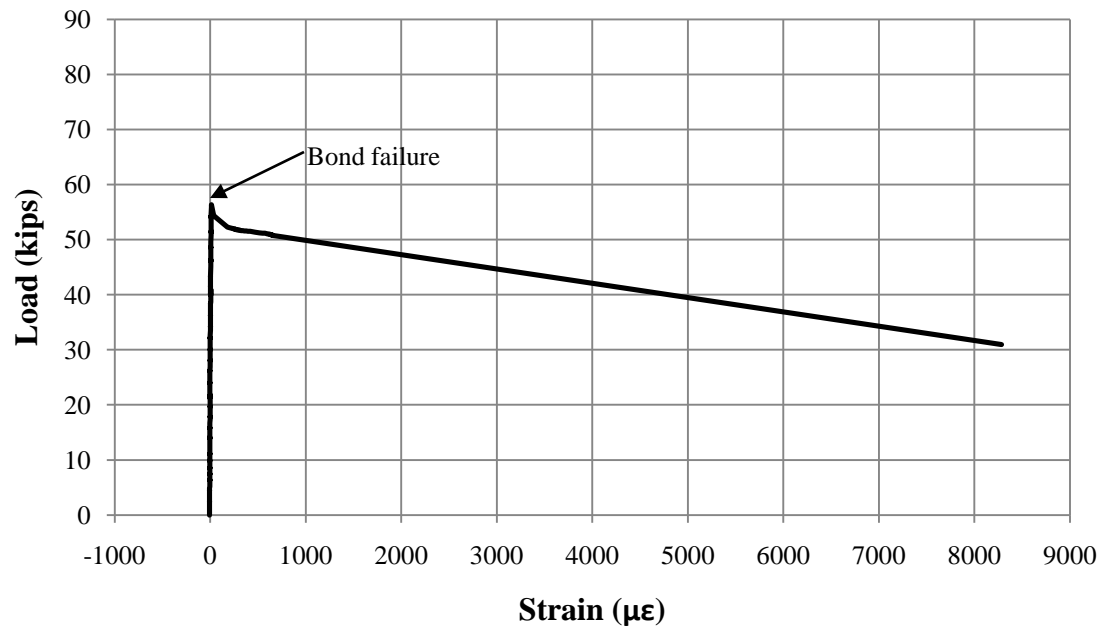
Figure 3.36: Measured shear stud strain (1-8000-6-k-6)

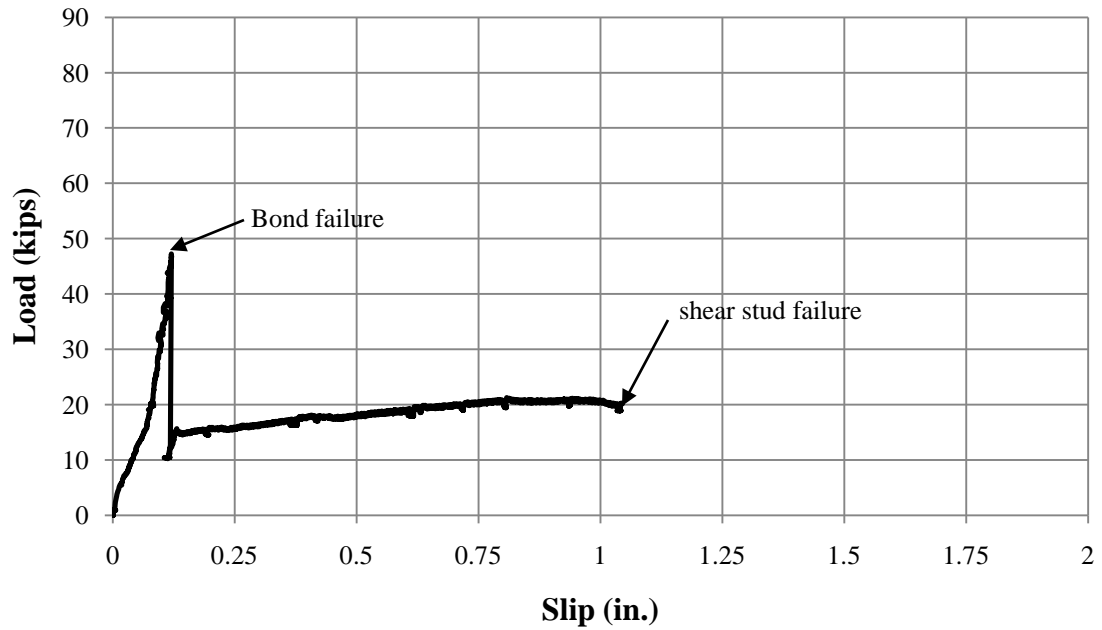
The load-slip response for Specimen 1-8000-6-k-4n is presented in Figure 3.38. The specimen behaved as a composite section up to a load of approximately 47.2 kips at which bond failure occurred at the panel-haunch interface. No cracking was observed prior to or following bond failure. Loading of the specimen continued until failure of the shear stud. As shown, after the significant decrease in capacity following bond failure, load was increased with increasing slip until the shear stud failed at a load of 21.2 kips. The panel section and failed shear stud are presented in Figure 3.39. A maximum measured strain of $8681 \mu\epsilon$ occurred immediately prior to shear stud failure (Figure 3.40).

Figure 3.38: Load-slip response for Specimen 1-8000-6-k-4n

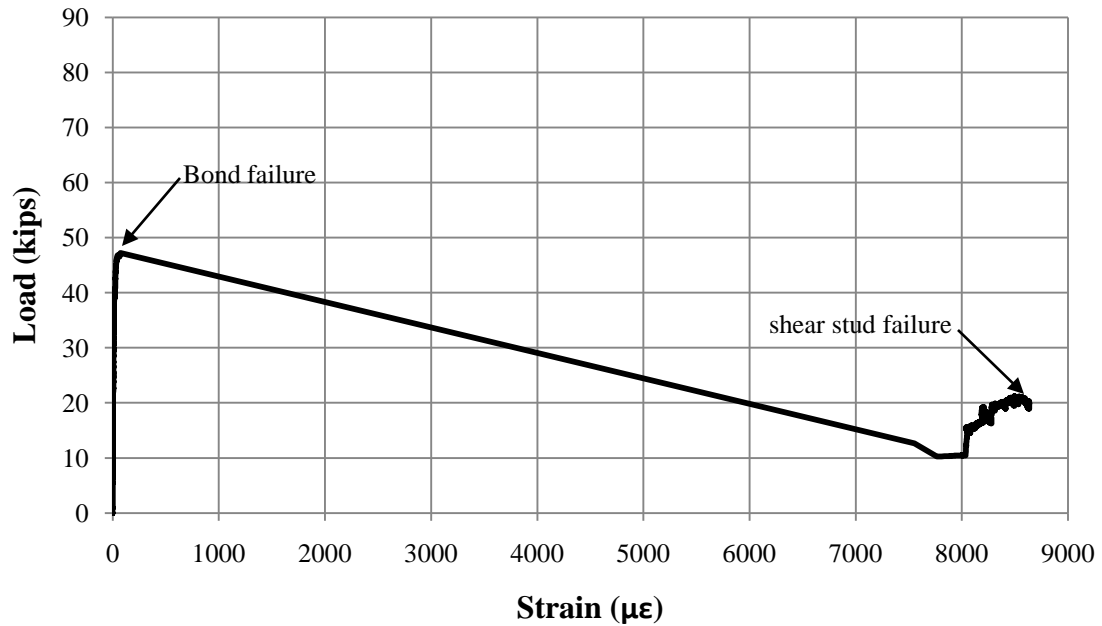
Figure 3.40: Measured shear stud strain (1-8000-6-k-4n)

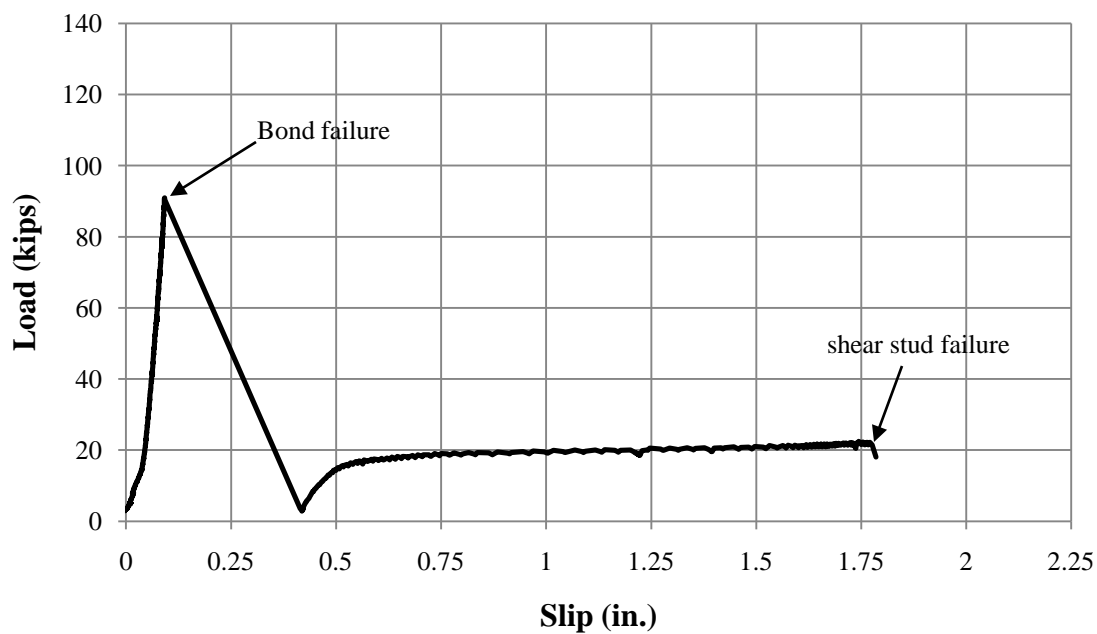
The load-slip response for Specimen 2-4000-6-4 is presented in Figure 3.41. The specimen behaved as a composite section up to a load of approximately 90.9 kips at which bond failure occurred at the panel-haunch interface. No cracking was observed prior to, or following bond failure. Loading of the specimen continued until failure of the shear stud. A maximum measured shear stud strain of 6543 $\mu\epsilon$ occurred immediately prior to failure of the shear stud (Figure 3.42). Measured strains indicate that the shear stud yielded. The panel section with failed shear stud is presented in Figure 3.43.

Figure 3.41: Load-slip response of Specimen 2-4000-6-4

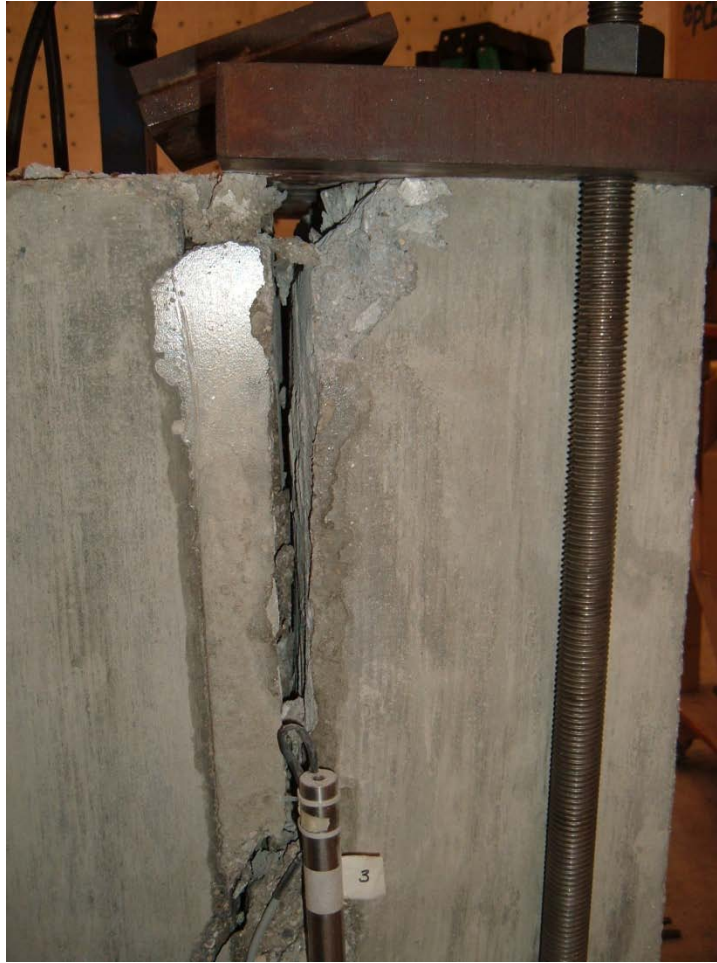
Figure 3.45: Rotation of panel section following second bond failure (2-4000-6-6)

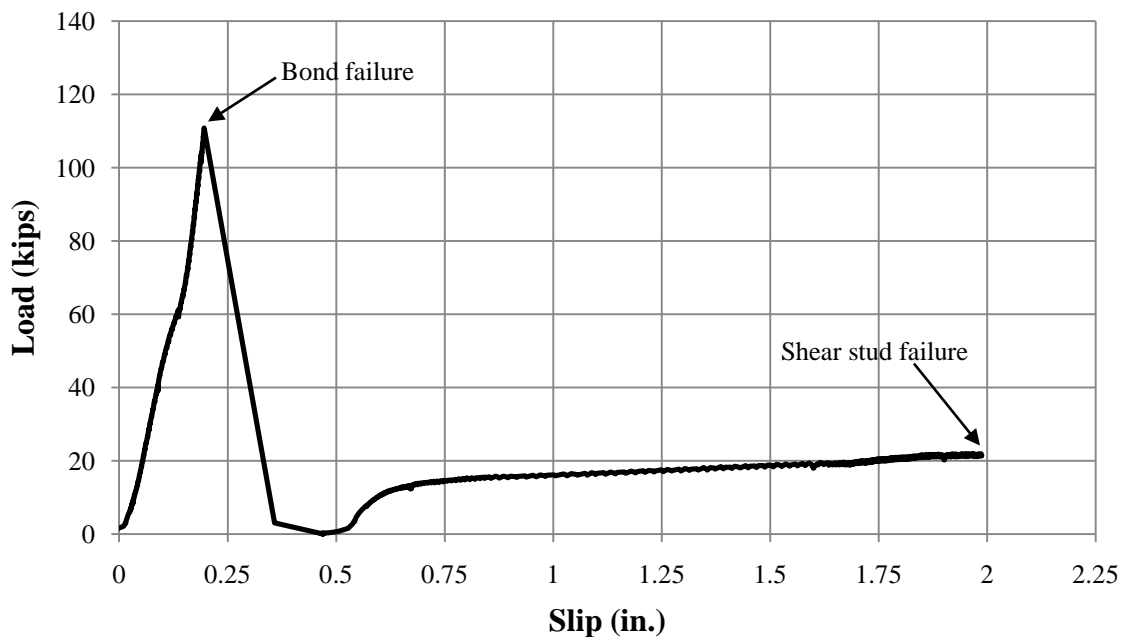
The load-slip response for Specimen 2-4000-6-k-4 is presented in Figure 3.48. The specimen behaved as a composite section up to a load of approximately 110.8 kips at which bond failure occurred at the panel-haunch interface. No cracking was observed prior to, or following bond failure. Loading of the specimen continued until failure of the shear stud, as presented in Figure 3.49. A maximum measured shear stud strain of $56 \mu\epsilon$ occurred prior to bond failure. The strain gauge went off-scale once bond failure occurred.

Figure 3.48: Load-slip response of Specimen 2-4000-6-k-4

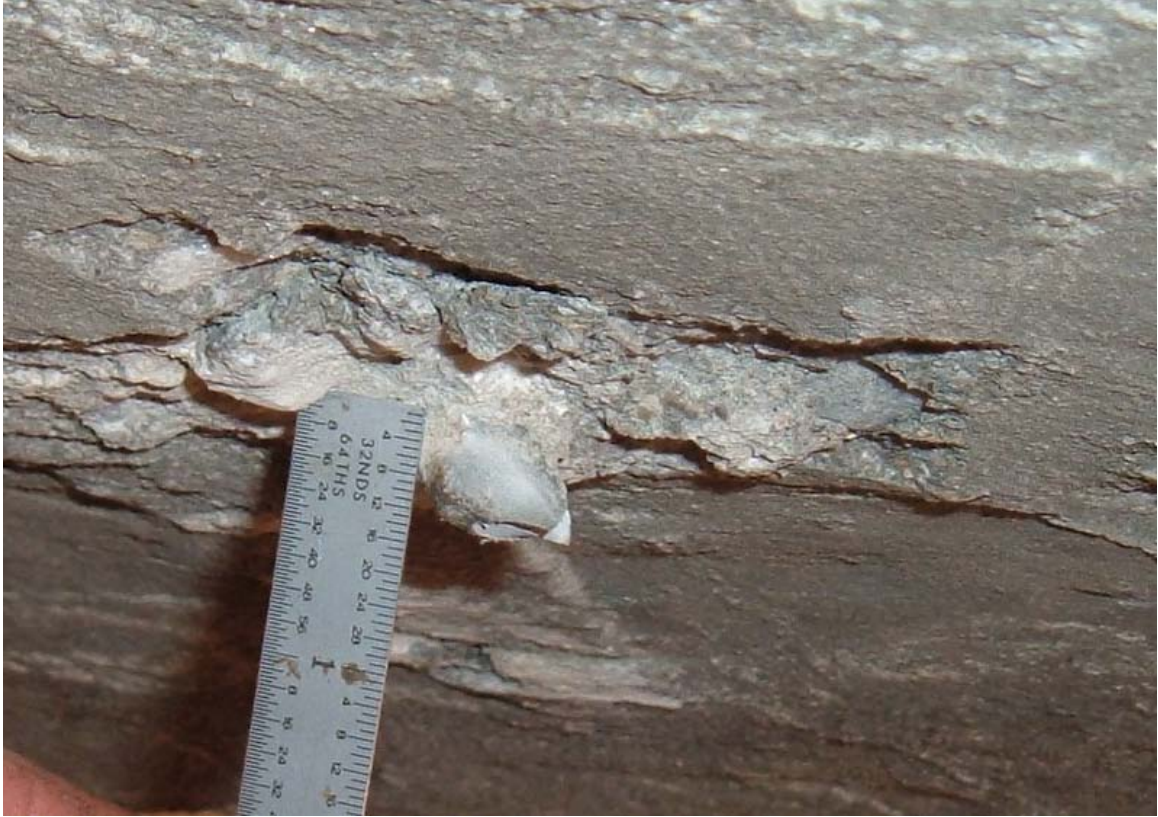
Figure 3.49: Failed shear stud of Specimen 2-4000-6-k-4

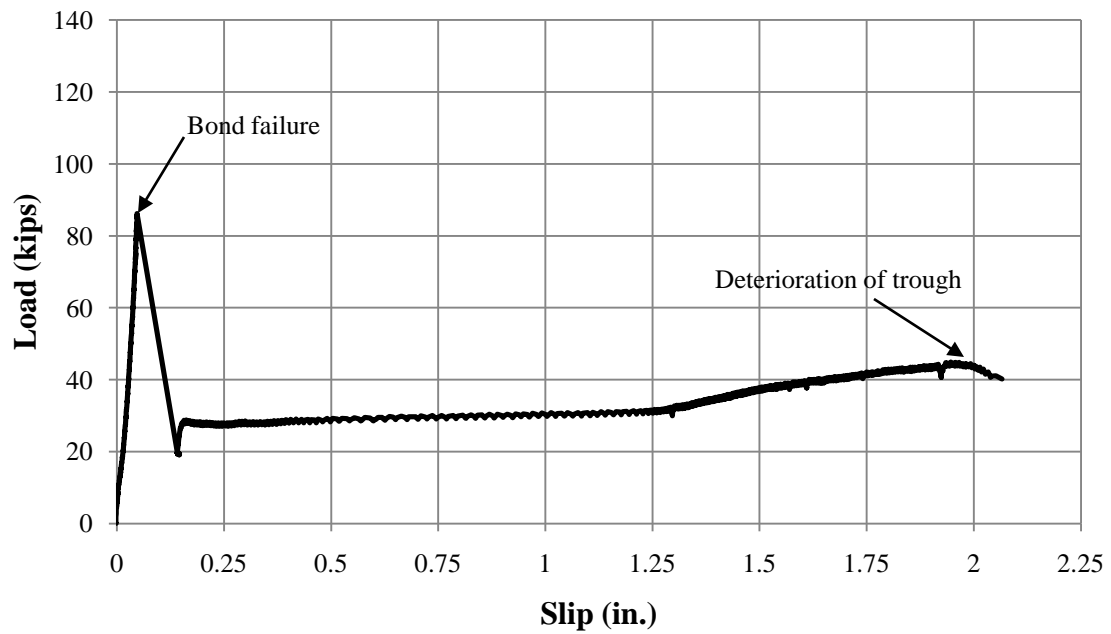
The load-slip response for Specimen 2-4000-6-k-6 is presented in Figure 3.50. The specimen behaved as a composite section up to a load of approximately 86.2 kips at which bond failure occurred at the panel-haunch interface. No cracking was observed prior to, or immediately following bond failure. However, after continued loading, a crack was observed at the base of the trough at approximately 40 kips. The crack propagated into the girder section, initiating at the inside corners of the trough. Loading of the specimen continued to a second peak load of 44.9 kips, at which time the trough material lost load capacity due to deterioration (Figure 3.51). A maximum measured shear stud strain of $4546 \mu\epsilon$ occurred at 40.6 kips (Figure 3.52). The strain gauge failed prior to the second peak load. Measured strains indicate that the shear stud yielded.

Figure 3.50: Load-slip response of Specimen 2-4000-6-k-6

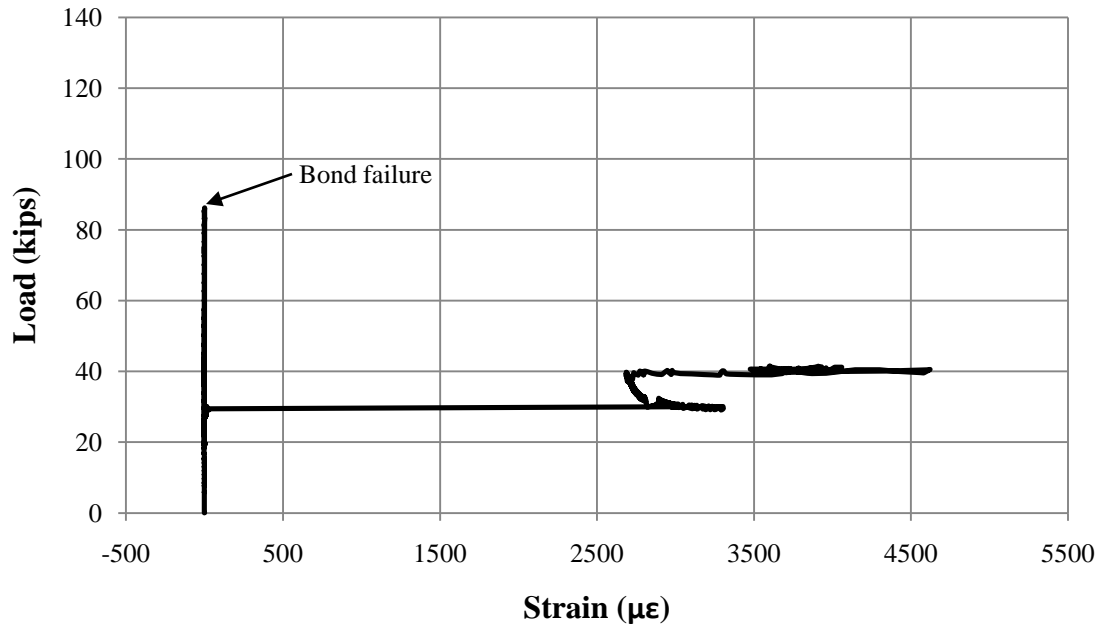
Figure 3.52: Measured shear stud strain (2-4000-6-k-6)

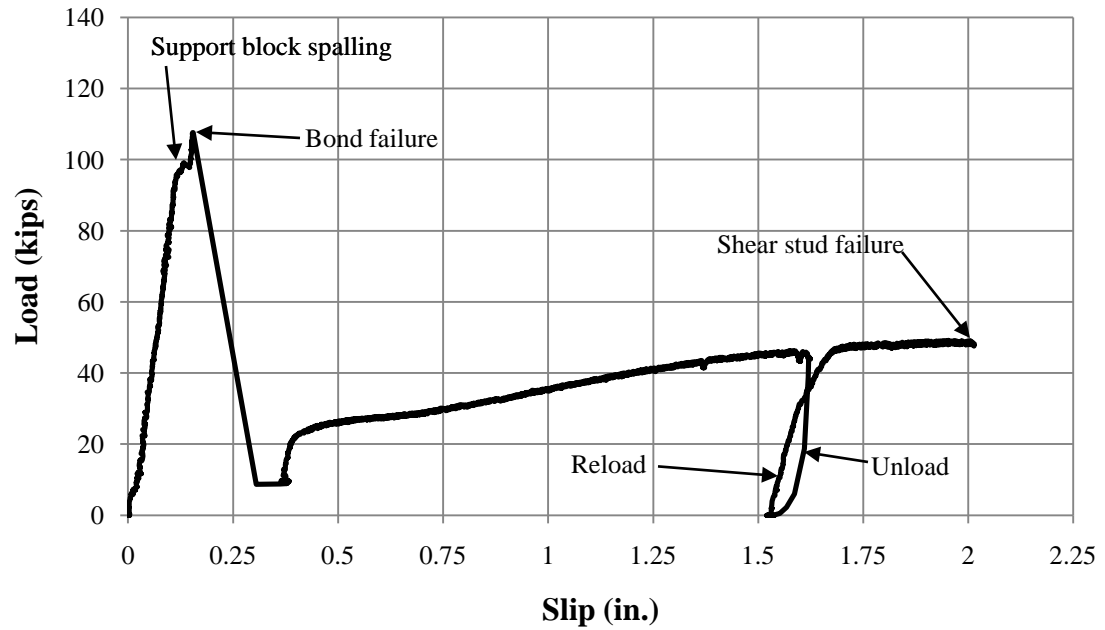
The load-slip response for Specimen 2-4000-6-k-6n is presented in Figure 3.53. The specimen behaved as a composite section up to a load of approximately 107.6 kips at which bond failure occurred at the panel-haunch interface. The non-linear response at approximately 100 kips was due to damage accumulation in the support block under the load location, which caused some spalling of the support block. No cracking of the specimen was observed prior to, or immediately following bond failure. Loading of the specimen continued to the maximum deflection of the test setup. The specimen was unloaded and a 2 in. spacing plate was installed under the loading plate to provide for additional deflection capacity of the test setup. The specimen was reloaded to 49.2 kips at which failure of the shear stud occurred (Figure 3.54). A maximum measured shear stud strain prior to unloading the specimen was 6161 $\mu\epsilon$, indicating that the shear stud had yielded (Figure 3.55). Upon reloading of the specimen, the strain gauge provided inconsistent readings and was considered unreliable.

Figure 3.53: Load-slip response for Specimen 2-4000-6-k-6n

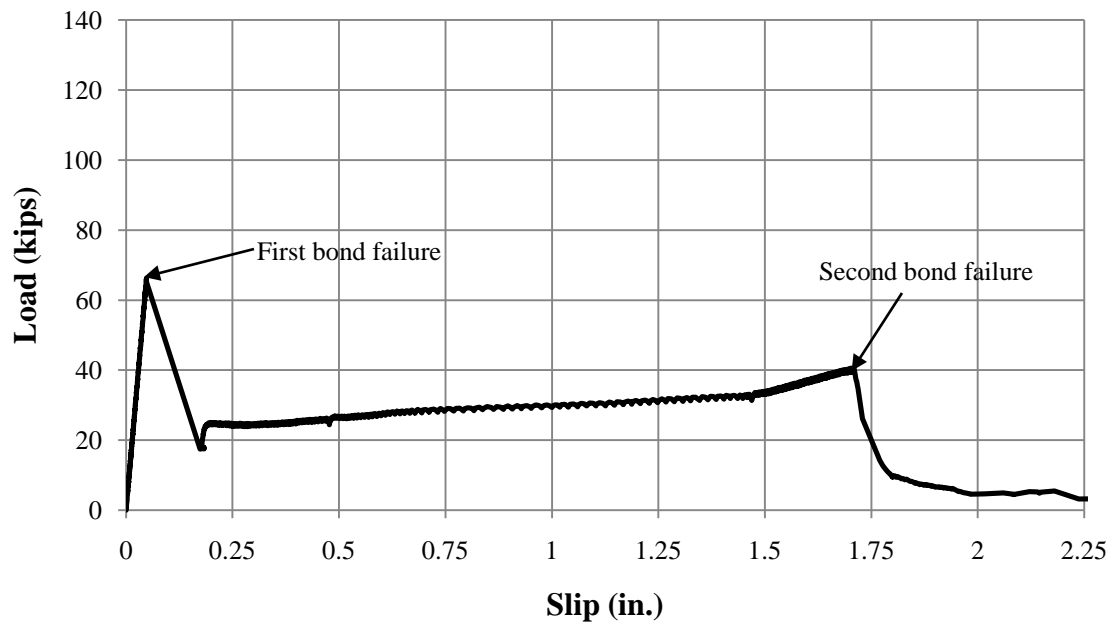
The load-slip response for Specimen 2-4000-8-6 is presented in Figure 3.56. The specimen behaved as a composite section up to a load of approximately 66 kips at which bond failure occurred at the panel-haunch interface. It should be noted that the haunch contained voids which resulted in a decreased bonding area (Figure 3.57). No cracking was observed prior to, or immediately following bond failure. Loading of the specimen continued to a second peak load of 40.5 kips. Upon reaching the second peak load, a bond failure occurred between the trough-girder section interface and the trough fractured at its mid-height (Figure 3.58). A maximum measured shear stud strain of 2189 $\mu\epsilon$ occurred immediately following the initial panel-haunch interface failure.

Figure 3.56: Load-slip response of Specimen 2-4000-8-6

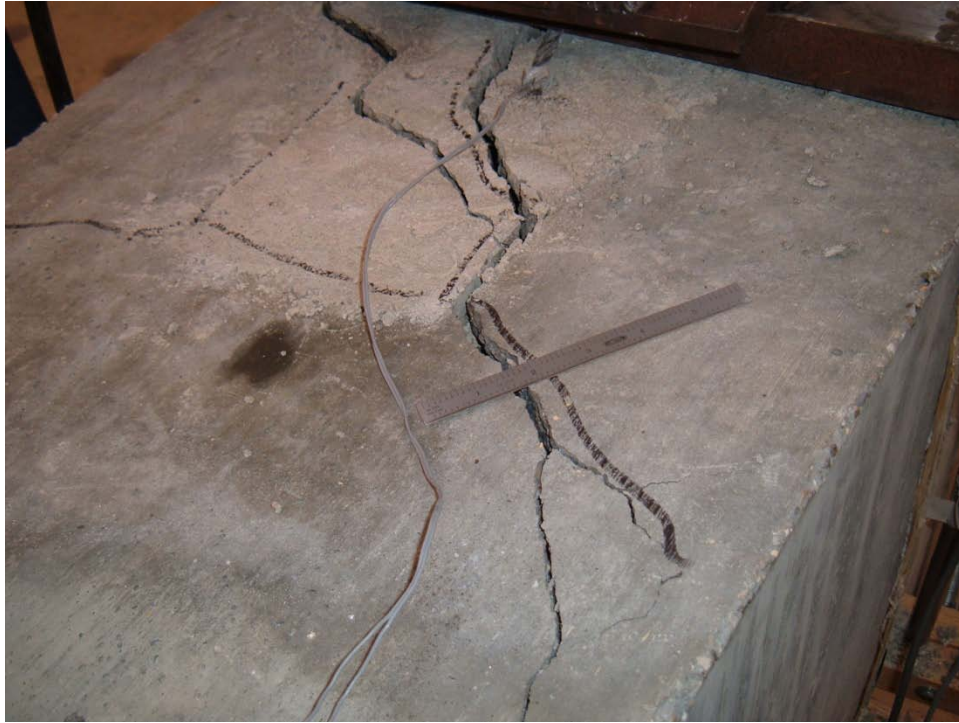
Figure 3.60: Cracking of Specimen 2-4000-8-k-6

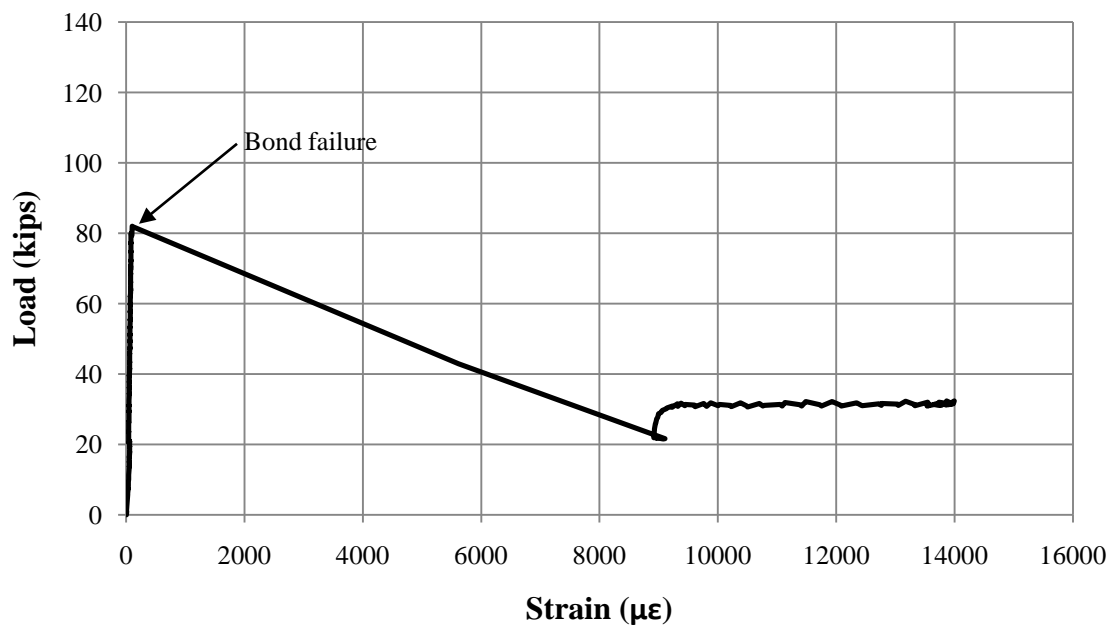
Figure 3.61: Measured shear stud strain (2-4000-8-k-6)

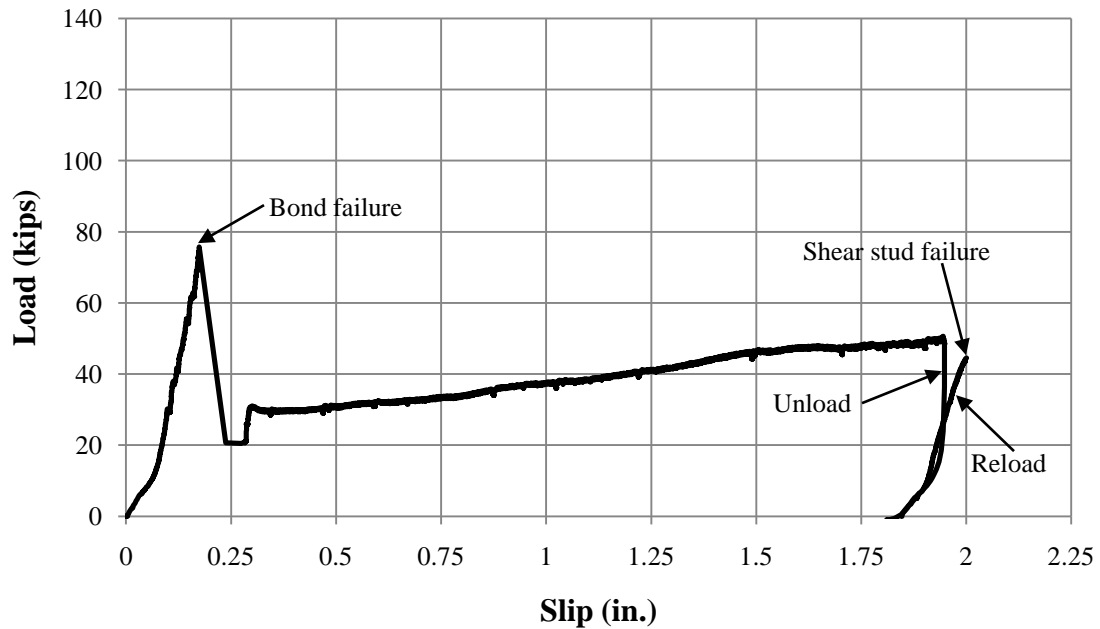
The load-slip response for Specimen 2-8000-6-k-6n is presented in Figure 3.62. The specimen behaved as a composite section up to a load of approximately 75.7 kips at which bond failure occurred at the panel-haunch interface. No cracking was observed prior to, or following bond failure. Loading of the specimen continued to the maximum deflection capacity of the test setup. The specimen was unloaded and a 2 in. spacing plate was installed under the loading plate to provide for additional deflection capacity. The specimen was reloaded to 44.5 kips at which failure of the shear stud occurred (Figure 3.63). A maximum measured shear stud strain of $100\ \mu\epsilon$ occurred immediately prior to bond failure. The strain gauge failed following bond failure.

Figure 3.62: Load-slip response of Specimen 2-8000-6-k-6n

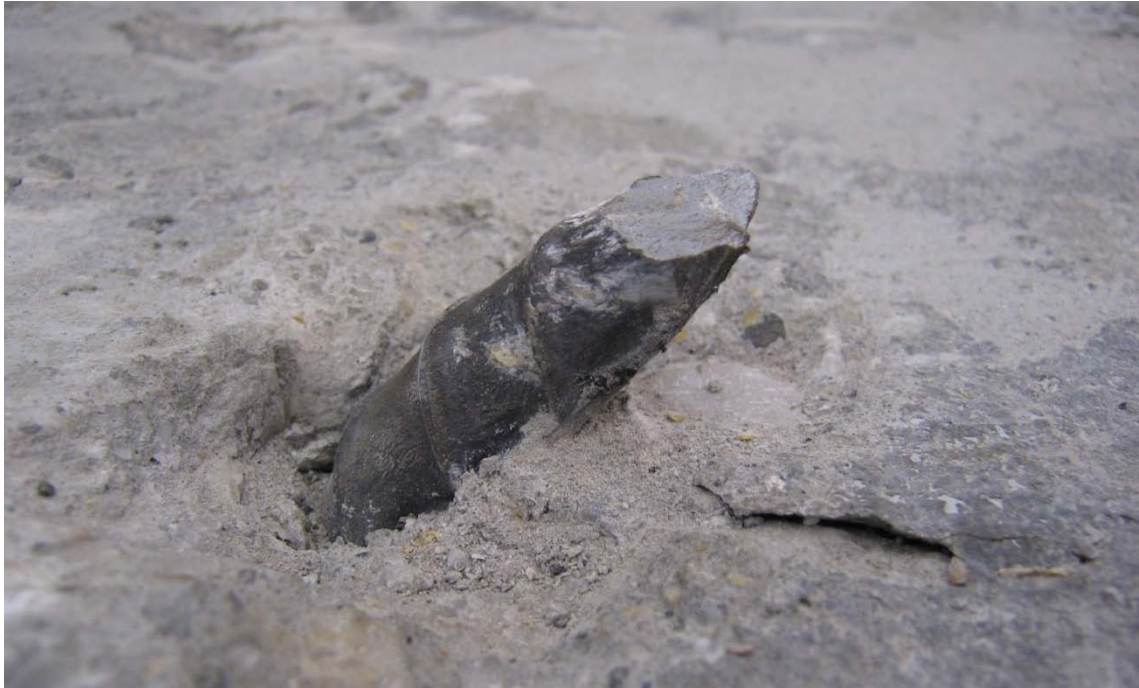
Figure 3.63: Failed shear stud of Specimen 2-8000-6-k-6n

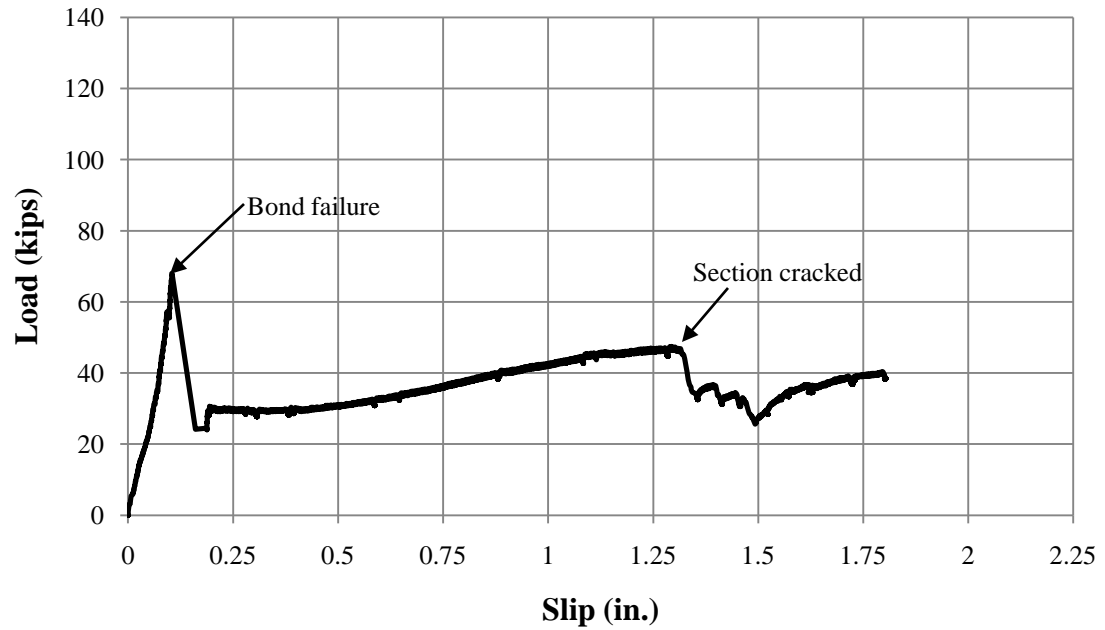
The load-slip response for Specimen 2-8000-6-k-6 is presented in Figure 3.64. The specimen behaved as a composite section up to a load of approximately 68 kips at which bond failure occurred at the panel-haunch interface. It should be noted that the haunch contained voids which resulted in a decreased bonding area (Figure 3.65). No cracking was observed prior to, or immediately following bond failure. Loading of the specimen continued to 36 kips where a crack in the girder section initiated at the bottom right corner of the trough. Loading continued to a second peak load of 47.5 kips was reached at which point the trough material cracked. The specimen continued to carry load. However, the initial cracks continued to widen and elongate (Figure 3.66). As loading continued the panel began to move away from the girder section, at which point the test was discontinued. A maximum measured shear stud strain of $59\ \mu\epsilon$ occurred just prior to bond failure. The strain gauge failed once bond failure occurred.

Figure 3.64: Load-slip response of Specimen 2-8000-6-k-6

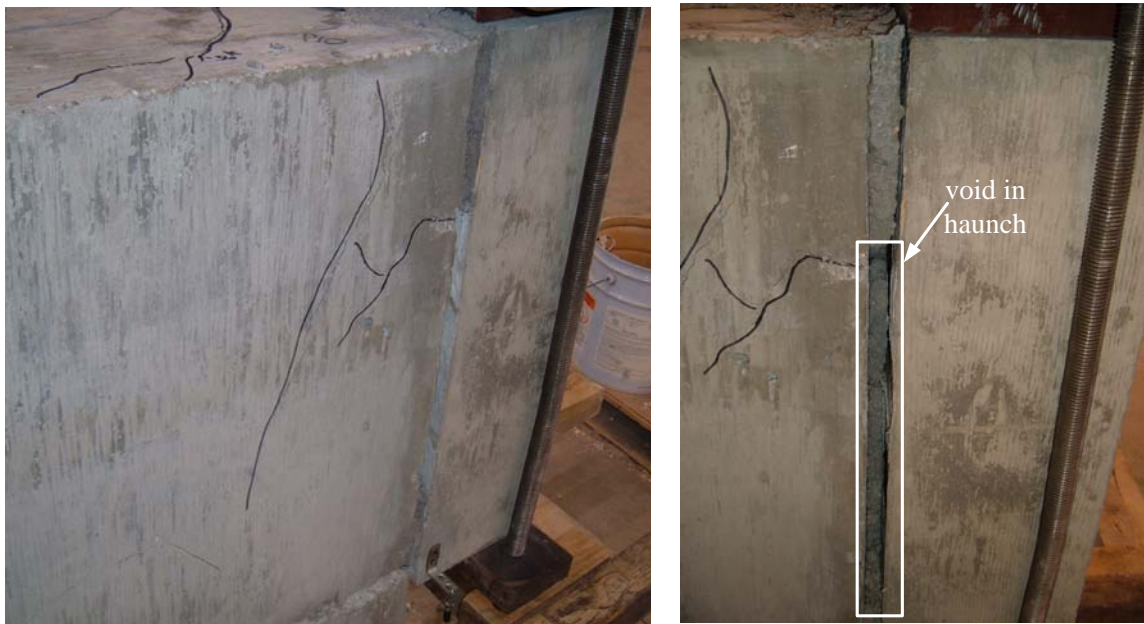
Figure 3.65: Girder section cracking and haunch void (2-8000-6-k-6)

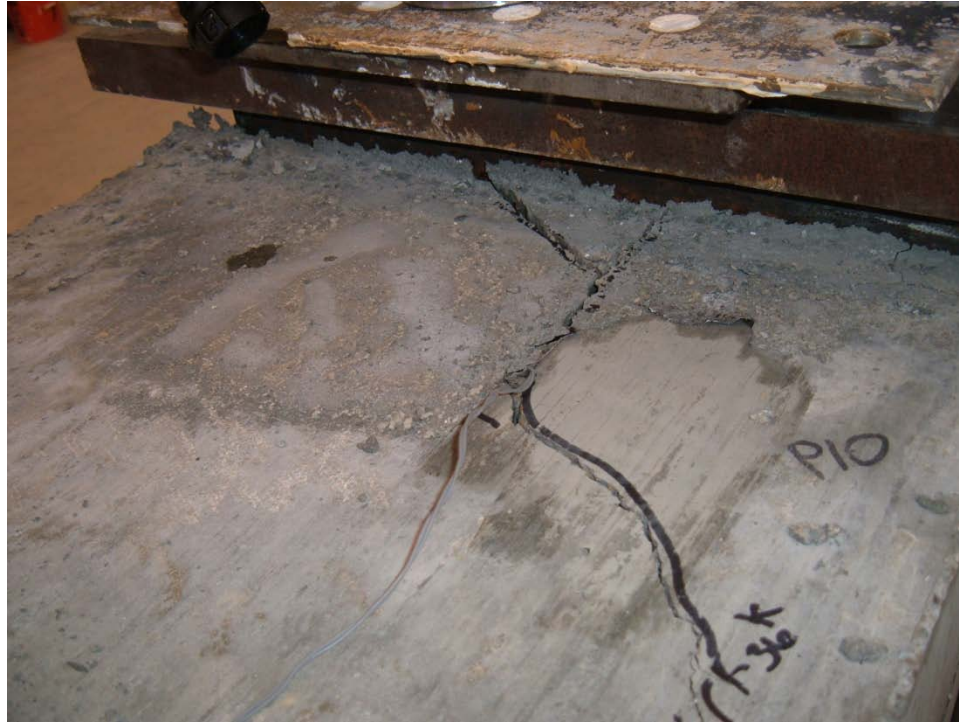
Figure 3.66: Trough and girder cracking of Specimen 2-8000-6-k-6

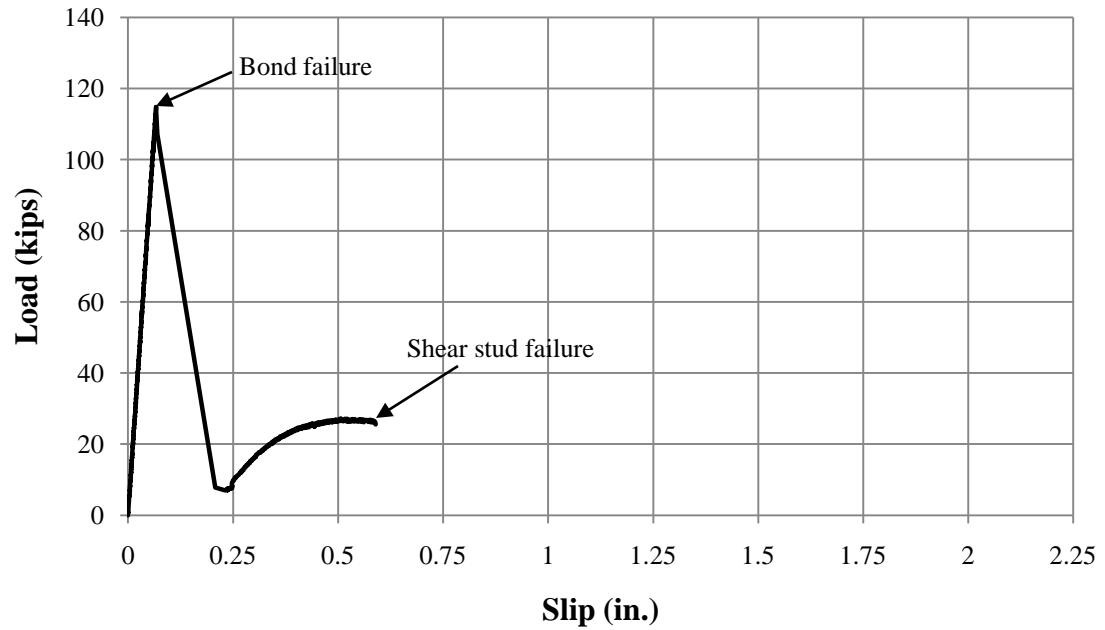
The load-slip response for New England system Specimen 2-6000-14-4 is presented in Figure 3.67. The specimen behaved as a composite section up to a load of approximately 114.8 kips at which failure occurred at the panel-haunch interface. No cracking was observed prior to, or following bond failure. Loading of the specimen continued to a second peak load of 27.2 kips at which point the shear stud failed. The panel section with failed shear stud is presented in Figure 3.68. A maximum measured shear stud strain of $3470 \mu\epsilon$ occurred immediately following bond failure (Figure 3.69). The strain gauge measured off-scale for the remainder of the test.

Figure 3.67: Load-slip response of Specimen 2-6000-14-4

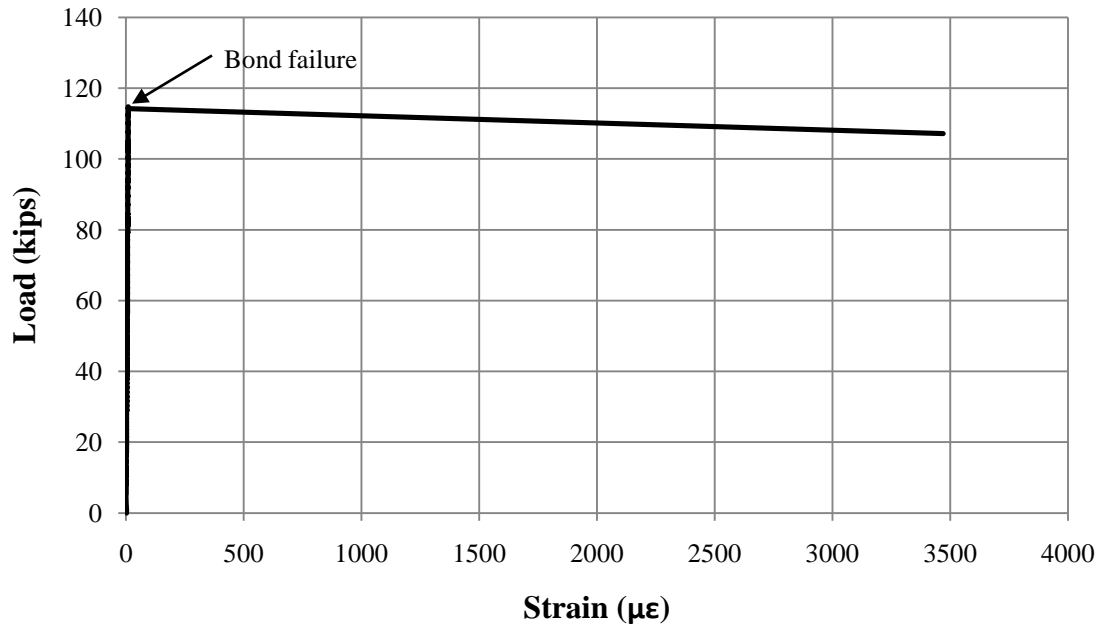
Figure 3.69: Measured shear stud strain (2-6000-14-4)

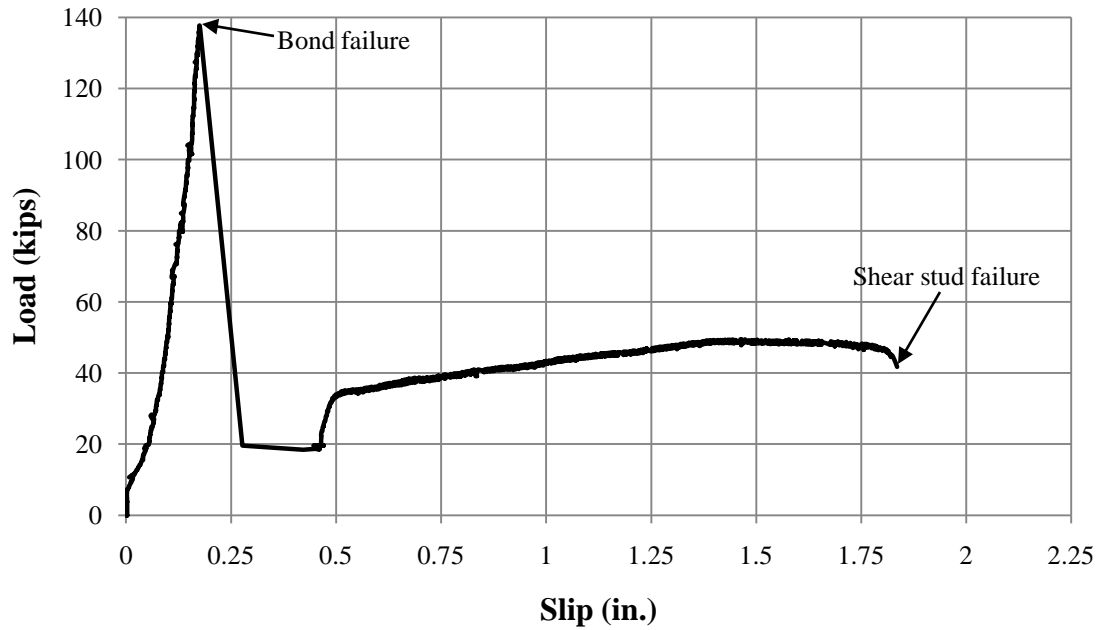
The load-slip response for New England system Specimen 2-6000-14-6 is presented in Figure 3.70. The specimen behaved as a composite section up to a load of approximately 137.7 kips at which failure occurred at the panel-haunch interface. No cracking was observed prior to, or following bond failure. Loading of the specimen continued to a second peak load of 49.5 kips. Shear stud failure occurred at a load of 41.8 kips, following the second peak. The panel section with failed shear stud is presented in Figure 3.71. A maximum measured shear stud strain of 120 $\mu\epsilon$ occurred just prior to bond failure. The strain gauge measured off-scale for the remainder of the test.

Figure 3.70: Load-slip response of Specimen 2-6000-14-6

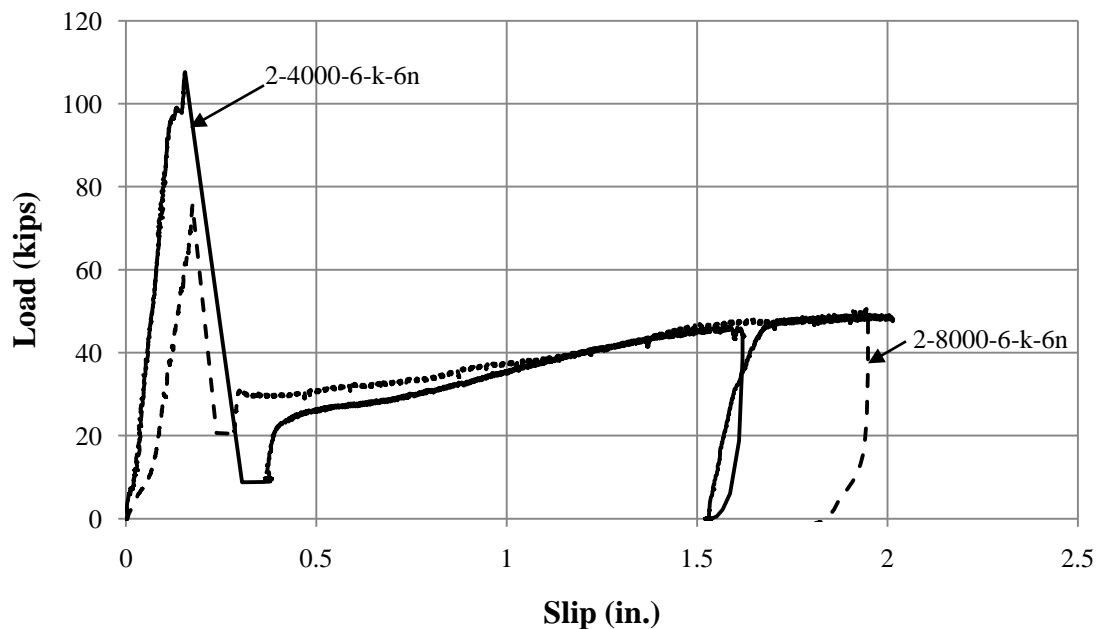
As shown in Figure 3.76, varying the compressive strength of the concrete used to fill the trough from 4,000 psi to 8,000 psi had no discernable influence on the final capacity of the specimen at shear stud failure. This finding indicates that once a minimum compressive strength for shear stud failure is provided, any excess strength has little influence on the behavior of the horizontal interface. As shown in Figure 3.76, similar post peak behavior (> 0.5 in. slip) was observed up to final failure.

Figure 3.76: Trough concrete strength comparison

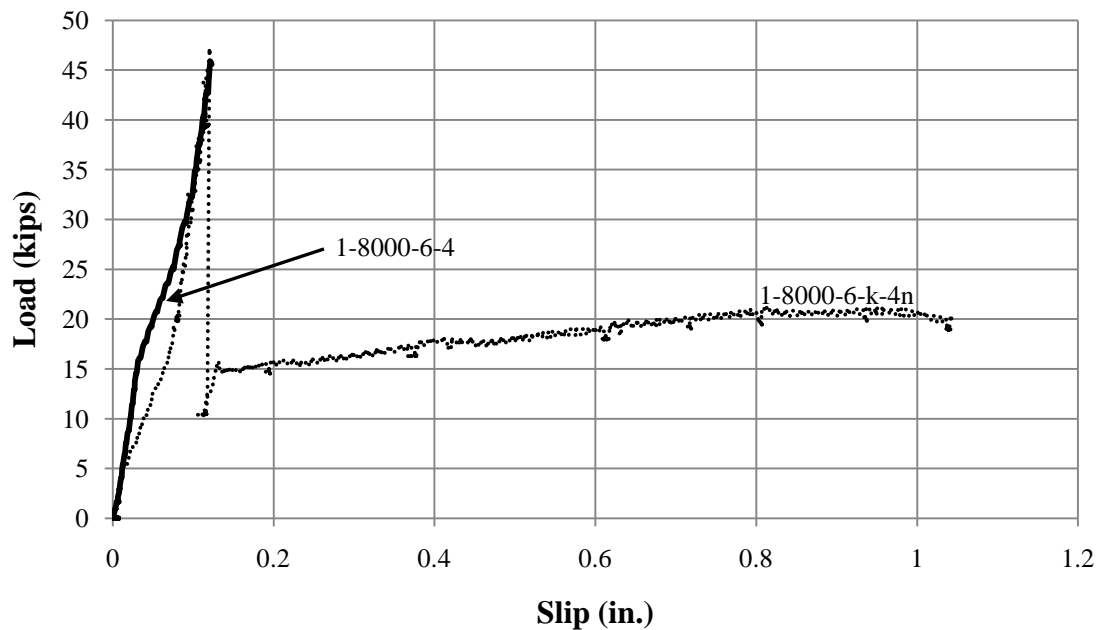
Figure 3.77: Trough detail comparison

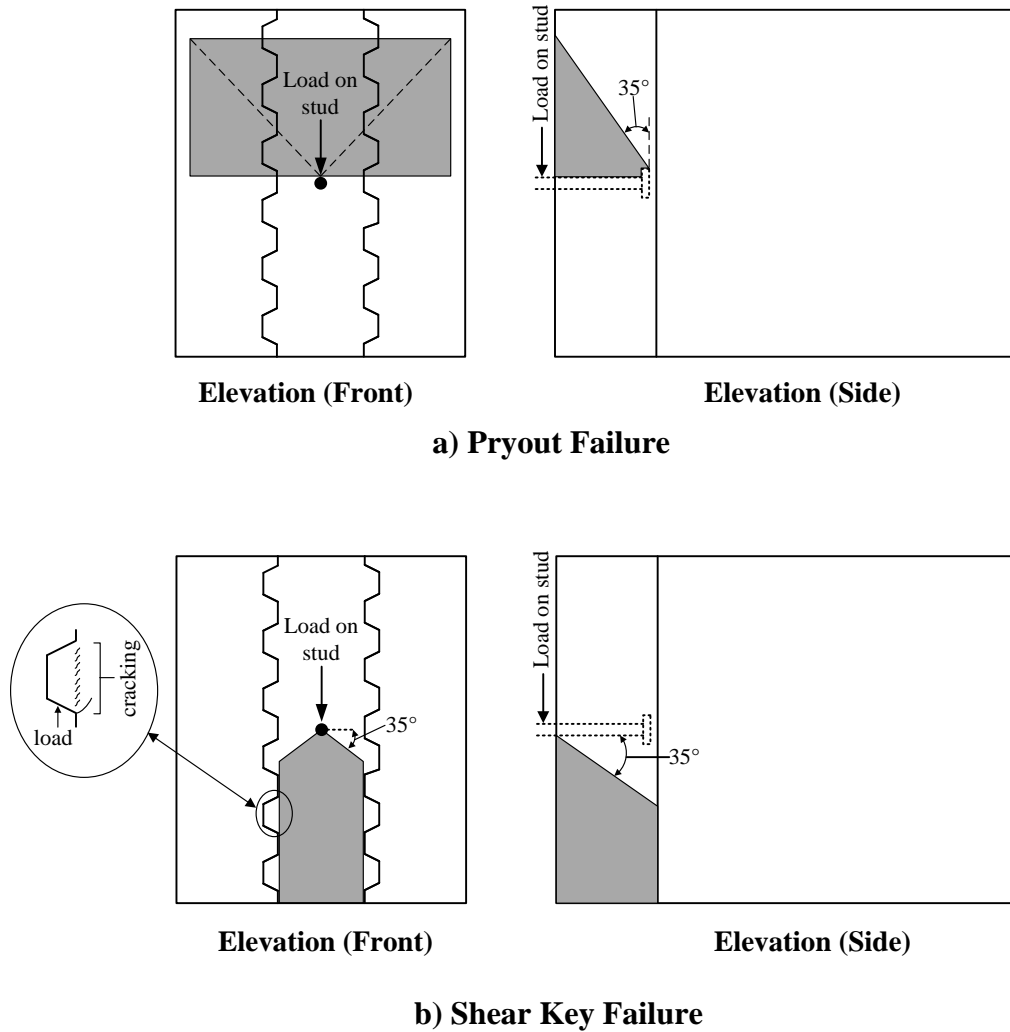
Figure 3.82: Additional idealized failure modes

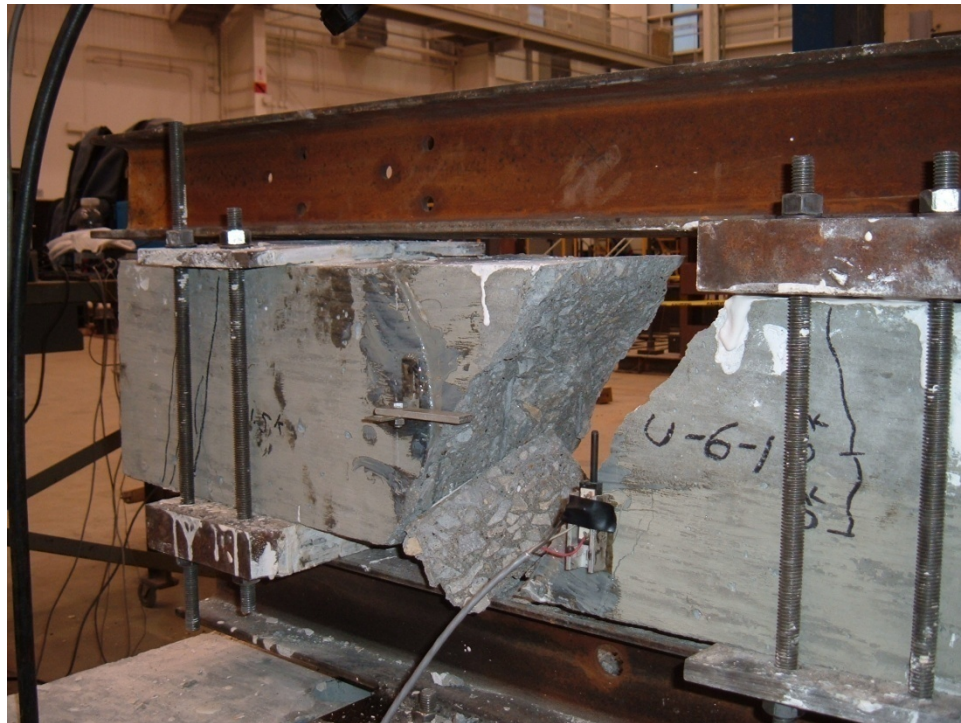
Figure 4.11: Failure of Specimen U-6-1

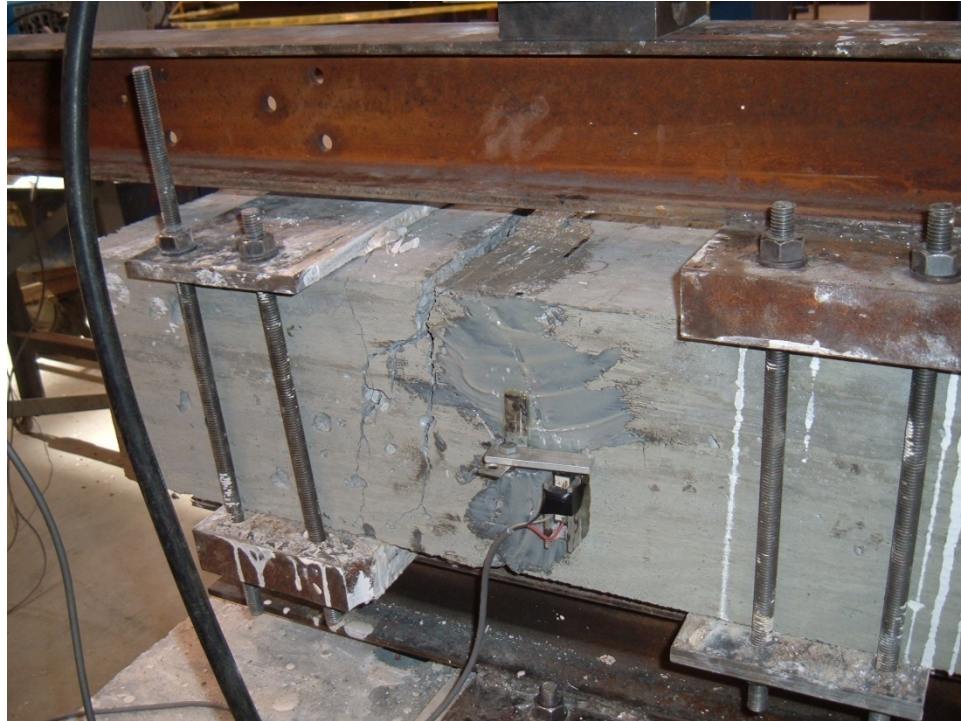
Figure 4.12: Failure of Specimen U-6-2

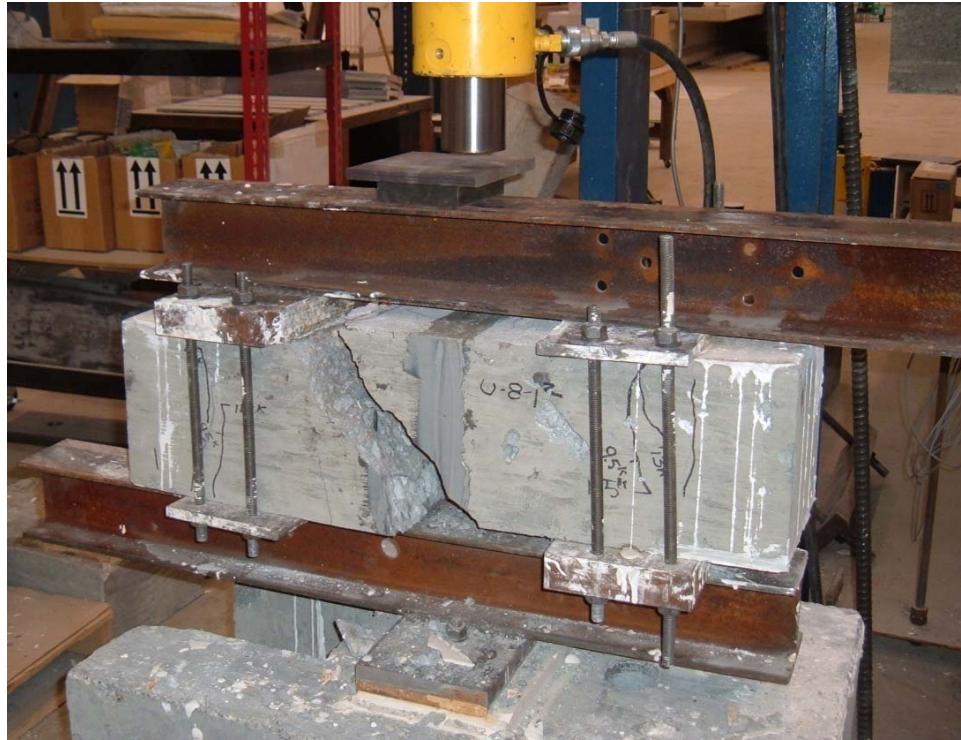
Figure 4.13: Failure of Specimen U-8-1

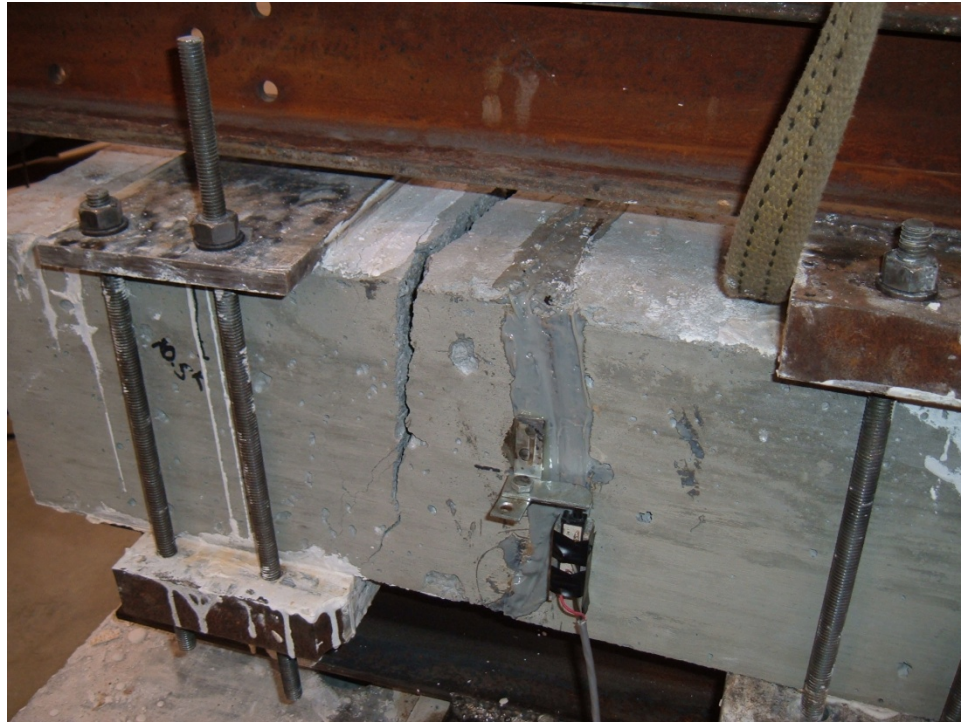
Figure 4.14: Failure of Specimen U-8-2
